**Superfund Five Year Review Report
Benfield Industries Site, Waynesville, NC
EPA ID: NC981026479**

**FINAL SUPERFUND FIVE YEAR REVIEW REPORT
BENFIELD INDUSTRIES SITE
EPA ID: NC981026479**

WAYNESVILLE, NORTH CAROLINA

August 2003

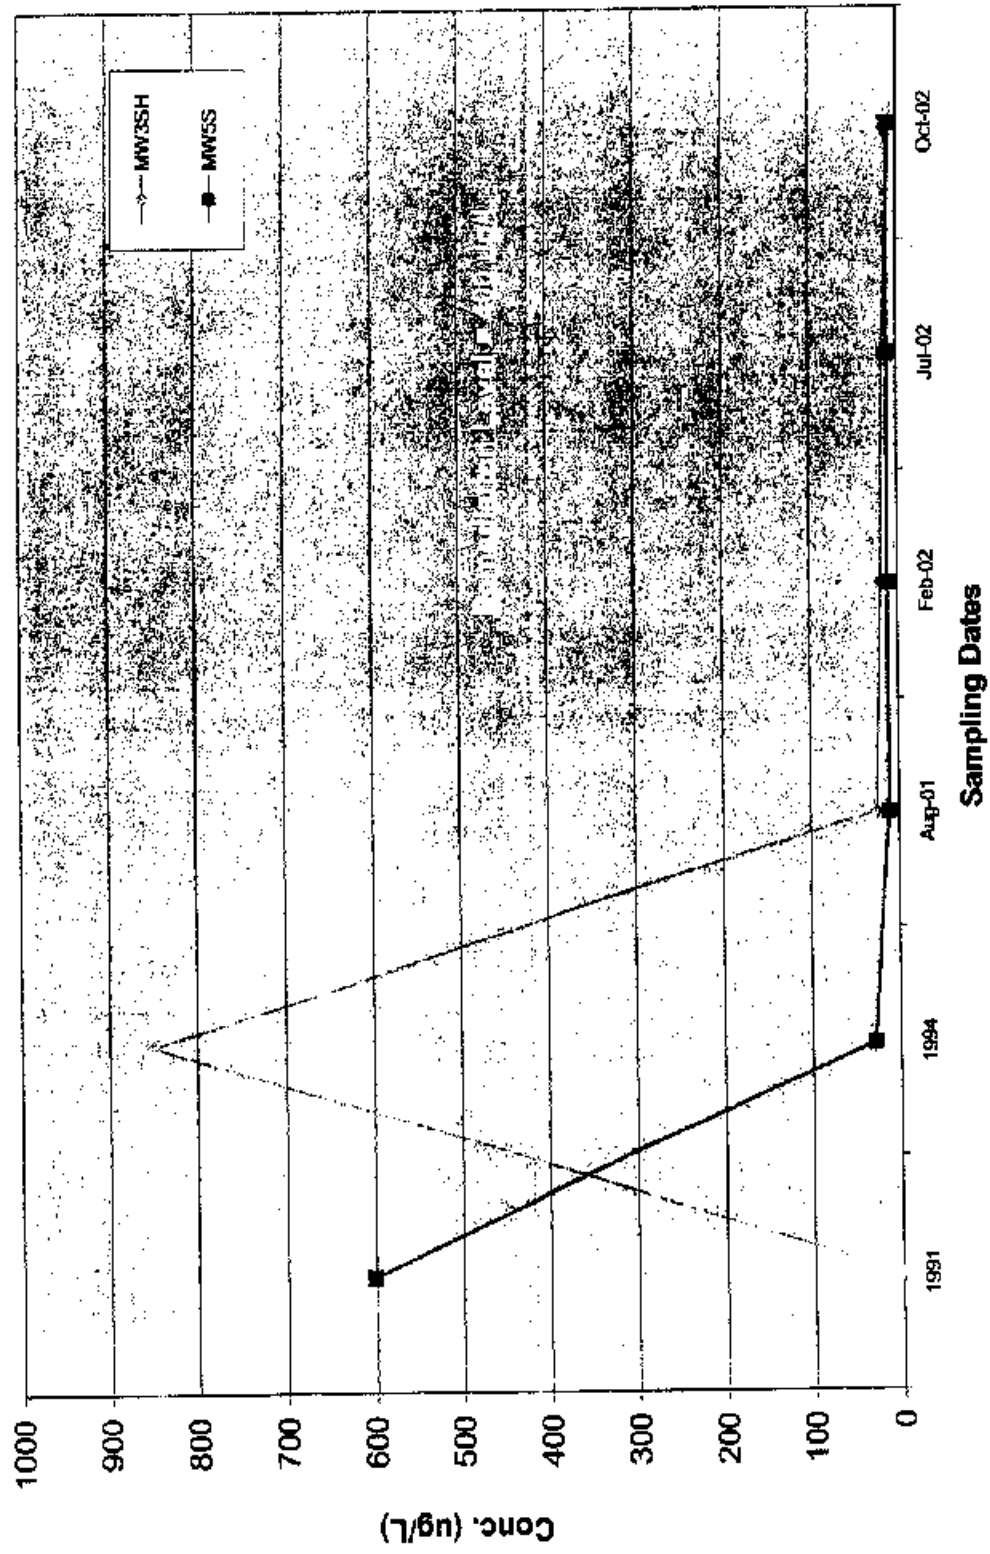
Figure 3. Groundwater Conc.-Xylenes

above paragraph. These plots are given as **Figures 3 through 8** for total xylenes, naphthalene, BaP, Ba, total Cr, and Mn, respectively. It should be noted that not all three wells were sampled for all sampling dates, and that the three wells represent two different groundwater zones/depths.
